A REPORT ON NONDESTRUCTIVE TESTING AND STRUCTURAL ANALYSIS ON ELEVEN IRON CASEMATE CARRIAGES AND CHASSIS

FORT SUMTER NATIONAL MONUMENT

April 2, 1979

LEE WAN and ASSOCIATES, INC.
engineers / architects / surveyors

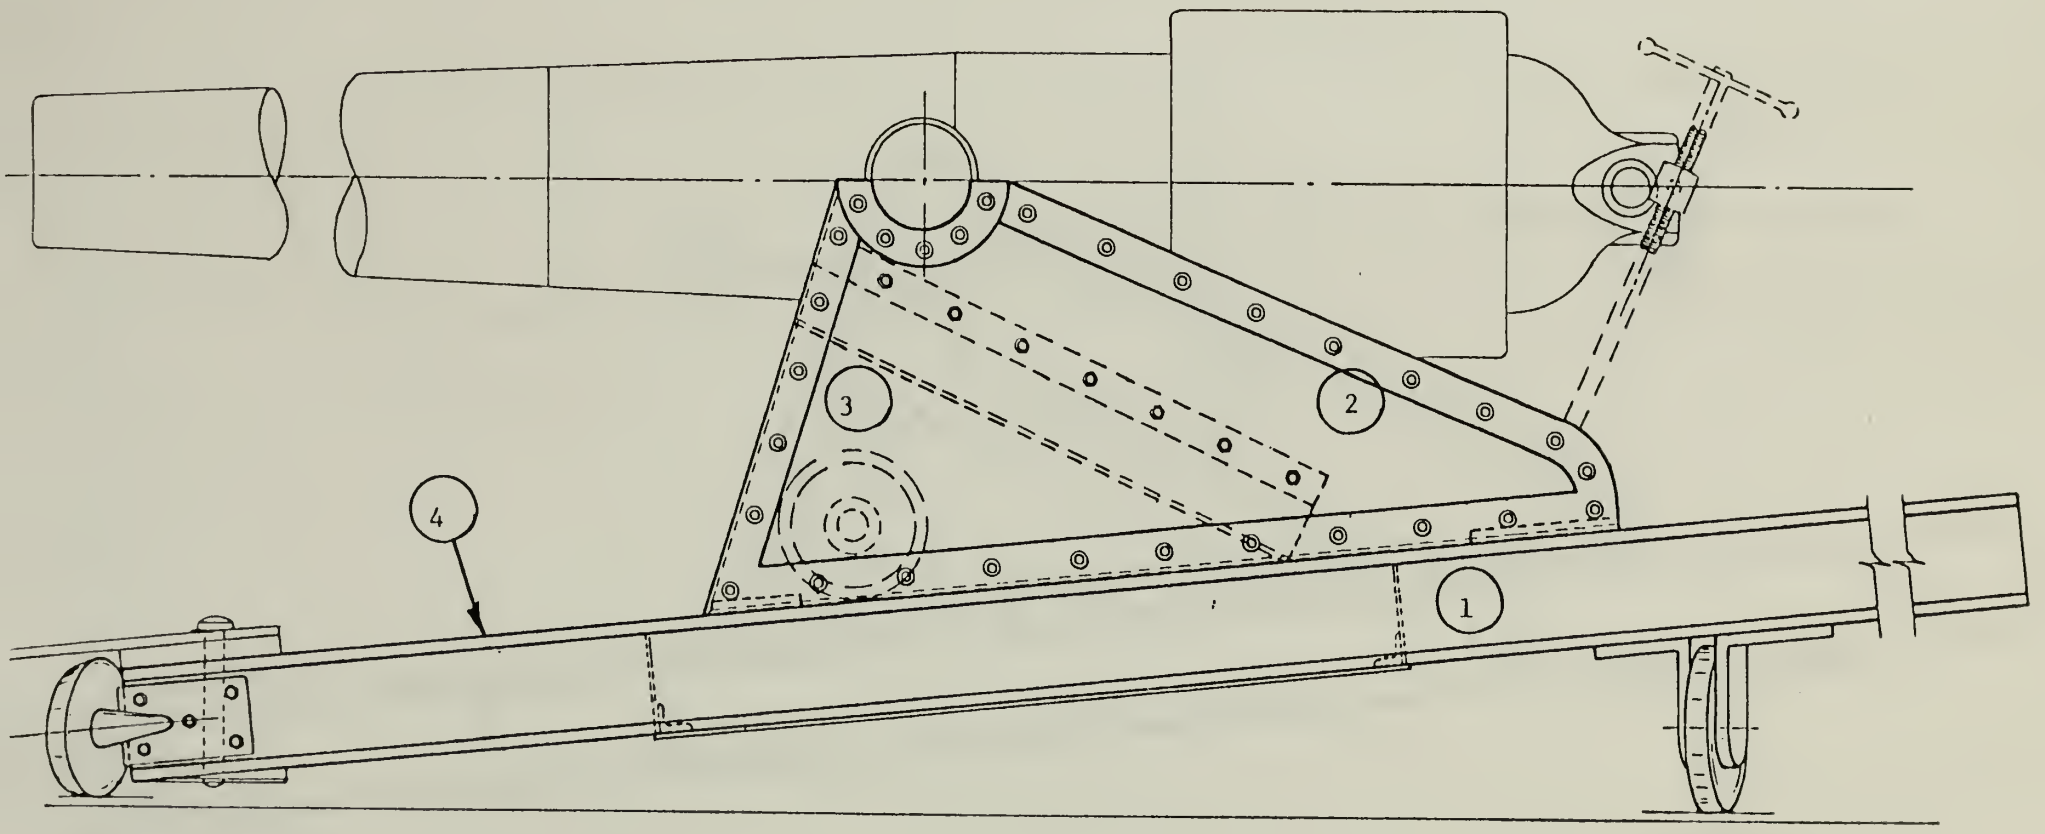
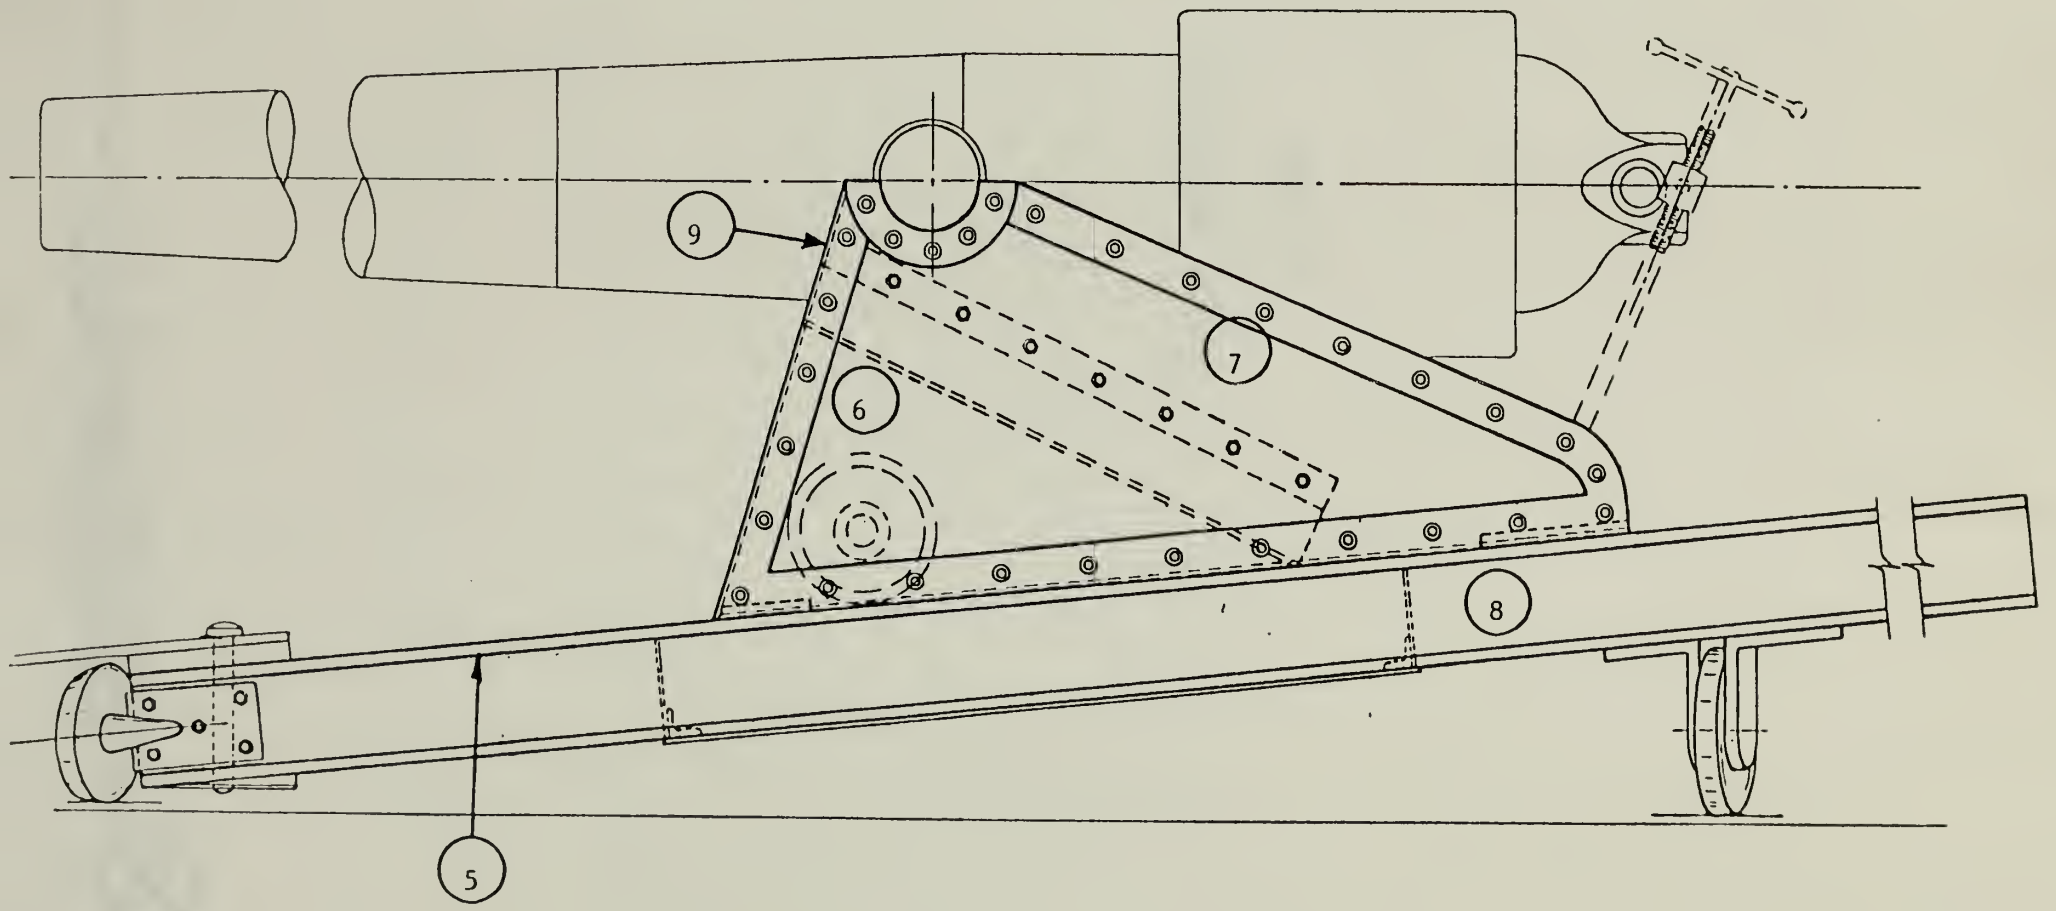
Cannon Number Eleven

#11 (For film locations refer to enclosed sketches)	1) View 4 reveals excessive wear but appears be from normal use. 2) View 5 indicates in-line indications and possible cracking. 3) View 9 reveals several areas rusted completely thru.

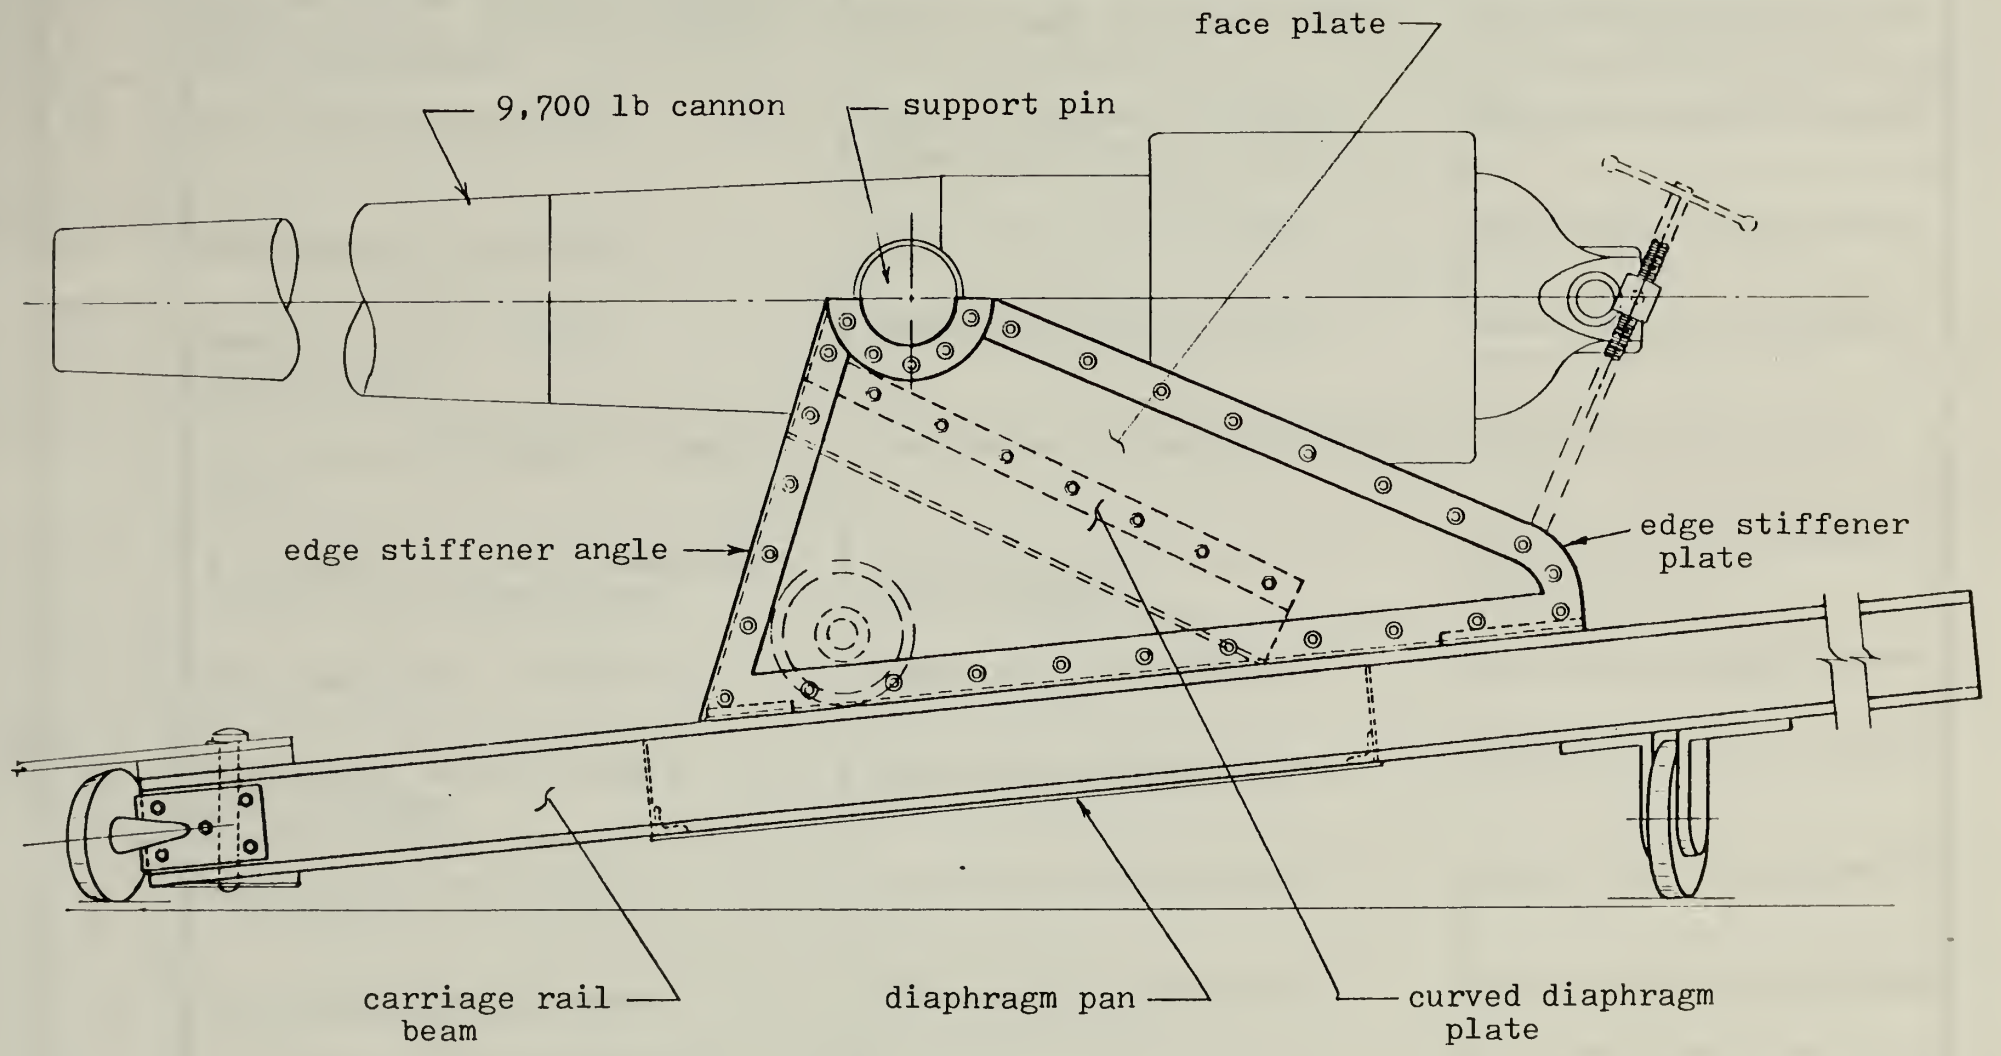
FIGURE 1. STRUCTURAL ELEMENTS

The principal structural elements are identified in figure 1. The weight of the 9700 lb cannon is supported by 8" diameter pins which in turn are supported by two 1/2" thick face plates. The face plates are edge-stiffened by plates or angles and are also mutually connected and braced by a 1/2" curved diaphragm plate. Each face plate is mounted on a 9" carriage beam. The cannon-pin-face plate assembly were movable in relation to the carriage beam. The carriage beams are supported by wheels that are travelable on concentric rails.

There are eleven cannons covered in this study. They had been buried in the sea sand for quite sometime before they were unearthed and displayed. Most of the cannons are heavily rusted, pitted, and flaked. Thinner elements such as curved diaphragm and diaphragm pan have rusted to a degree that large holes have been observed. The carriage wheels have mostly rusted to flakes that crumble. Fortunately, main load carring elements, such as side plates and carriage beams were all made of thicker plates. After deterioration, there are still substantial portions of metal left to offer support to the 9700 lb cannon.

It is felt that conventional sandblasting and multi-coat protective painting will be sufficently effective and economical to protect the base metal from being further deteriorated. It is therefore, so recommended.
